AL SUMELAT
WATER NETWORK
VILLAGE OF AL SUMELAT, IRAQ

SIGIR PA-05-004
MARCH 15, 2006

Special Inspector General for Iraq Reconstruction

Al Sumelat Water Network Village of Al Sumelat, Iraq Synopsis

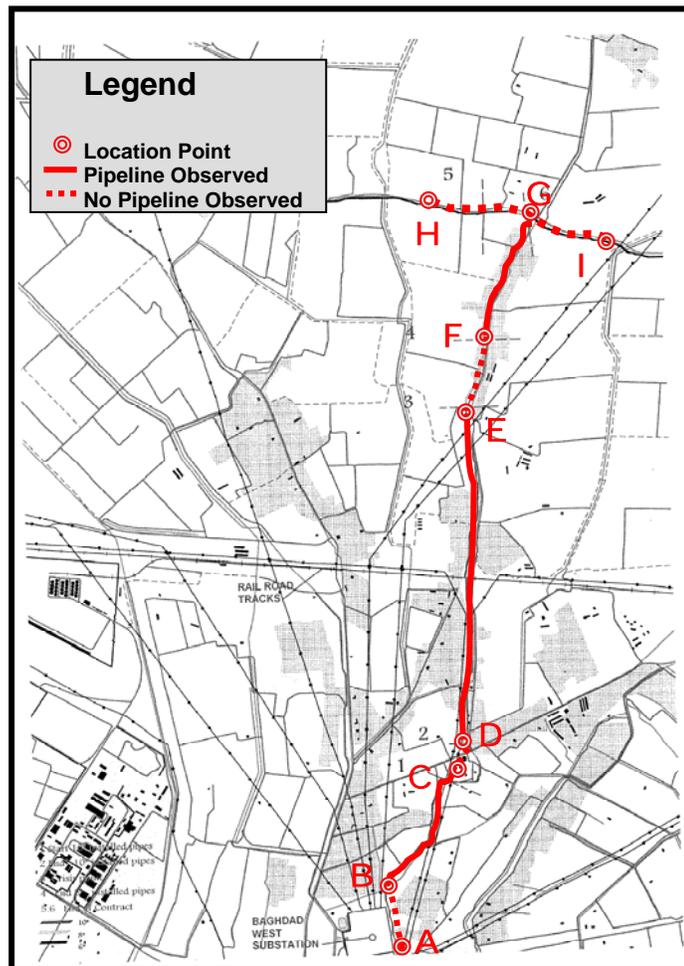
Figure 1: Al Sumelat Pipeline Location Map

Point A to B: The approximate length of the pipeline from point A to point B (see the locator map in Figure 1 on page 4) is 840 meters. Disturbed soil leading in the direction of the pipeline route was observed from point A. The disturbed soil appeared to be the result of a recent trench excavation and subsequent backfilling of the trench (Site photo 2). It could not be determined how far this excavation continued. The starting point of the pipeline was not visibly protruding from the disturbed soils and could not be located at point A. An observation at point B leading back toward point A along the proposed pipeline path was of an open field showing no recently disturbed soil (Site photo 3). Consequently, no evidence that the pipeline had been installed between points A and B was found.

Point B: Point B on the locator map in Figure 1 on page 4 is the point at which the pipeline route crosses underneath an irrigation canal. A recently excavated tunnel approximately 1 meter by 1/2 meter was observed underneath the irrigation canal. The pipeline was not visible leading into (Site photo 4) or exiting the

Point B to C: The approximate length of the pipeline from point B to point C (see the locator map in Figure 1 on page 4) is 1,495 meters. Uncapped endpoints of the pipeline were observed at both points B and C (Site photos 5 & 6). The pipe diameter looked to be approximately 225 millimeters, but accurate measurements were not obtained at this location. Disturbed surface soil was observed continuously between points B and C along the proposed pipeline route. The disturbed soil appeared to be the result of a recent trench excavation and subsequent backfilling of the trench. A sand base was not present at the endpoints of the pipeline. A significant amount of unconsolidated soil was observed above grade along the pipeline path. Lack of compacting during backfilling operations would result in the presence of the observed excess soil. The surface of the disturbed soil was uneven with several feet variation in height along the pipeline route. This indicates that final surface grading was not completed. It appeared, based on site assessment observations, that the pipeline had been installed between points B and C, but the pipeline installation was not consistent with contract requirements.

Point C to D: The approximate length of the pipeline from point C to point D (see the locator map in Figure 1 on page 4) is 110 meters. The pipeline route crosses a road intersection at this location. A recently excavated tunnel approximately 1 meter by ½ meter was observed beneath the road intersection.

Point D to E: The pipeline leg from point D to point E (see the locator map in Figure 1 on page 4) is approximately 3,389 meters in length. This section parallels the road and crosses underneath a set of railroad tracks. The endpoint could not be located at point D and an uncapped endpoint of 225 millimeter diameter pipeline was observed at point E. Disturbed surface soil was observed continuously between points D and E along the proposed pipeline route. The disturbed soil appeared to be the result of a recent trench excavation and subsequent backfilling of the trench. A sand base was not present at the endpoints of the pipeline. A significant amount of unconsolidated soil was observed above grade along the pipeline path. Lack of compacting during backfilling operations would result in the presence of the excess soil. The surface of the disturbed soil was uneven with several feet variation in height along the pipeline route. This demonstrates final surface grading was not completed. It appeared, based on site assessment observations, that the pipeline had been installed between points D and E, but the pipeline installation was not consistent with contract requirements.

Point E to F: The pipeline leg from point E to point F (see the locator map in Figure 1 on page 4) is approximately 703 meters in length. This section parallels and crosses under the roadway. A recently dug open trench approximately 1 meter in depth was observed along the proposed pipeline route. Pipe was not visible and the bottom of the trench excavation appeared to be undisturbed soil. At the location where the proposed pipeline route crosses underneath the road a recently excavated tunnel, approximately 1 meter by ½ meter was observed. The pipeline was not visible and could not be located leading into or exiting the tunnel. The bottom of the tunnel excavation appeared to be undisturbed soil. Consequently, no evidence that the pipeline had been installed between points E and F was found. Prior to the site visit, this section of the pipeline was identified as not being completed by the USACE Quality Assurance Representative and is listed in this report under the section on “Work Pending.”
